# **Four Firefighters Killed, Trapped by Floor Collapse Brackenridge, Pennsylvania (December 20, 1991)**

**Investigated by: J. Gordon Routley**

**This is Report 061 of the Major Fires Investigation Project conducted  
by TriData Corporation under contract EMW-90-C-3338 to the United  
States Fire Administration, Federal Emergency Management Agency.**

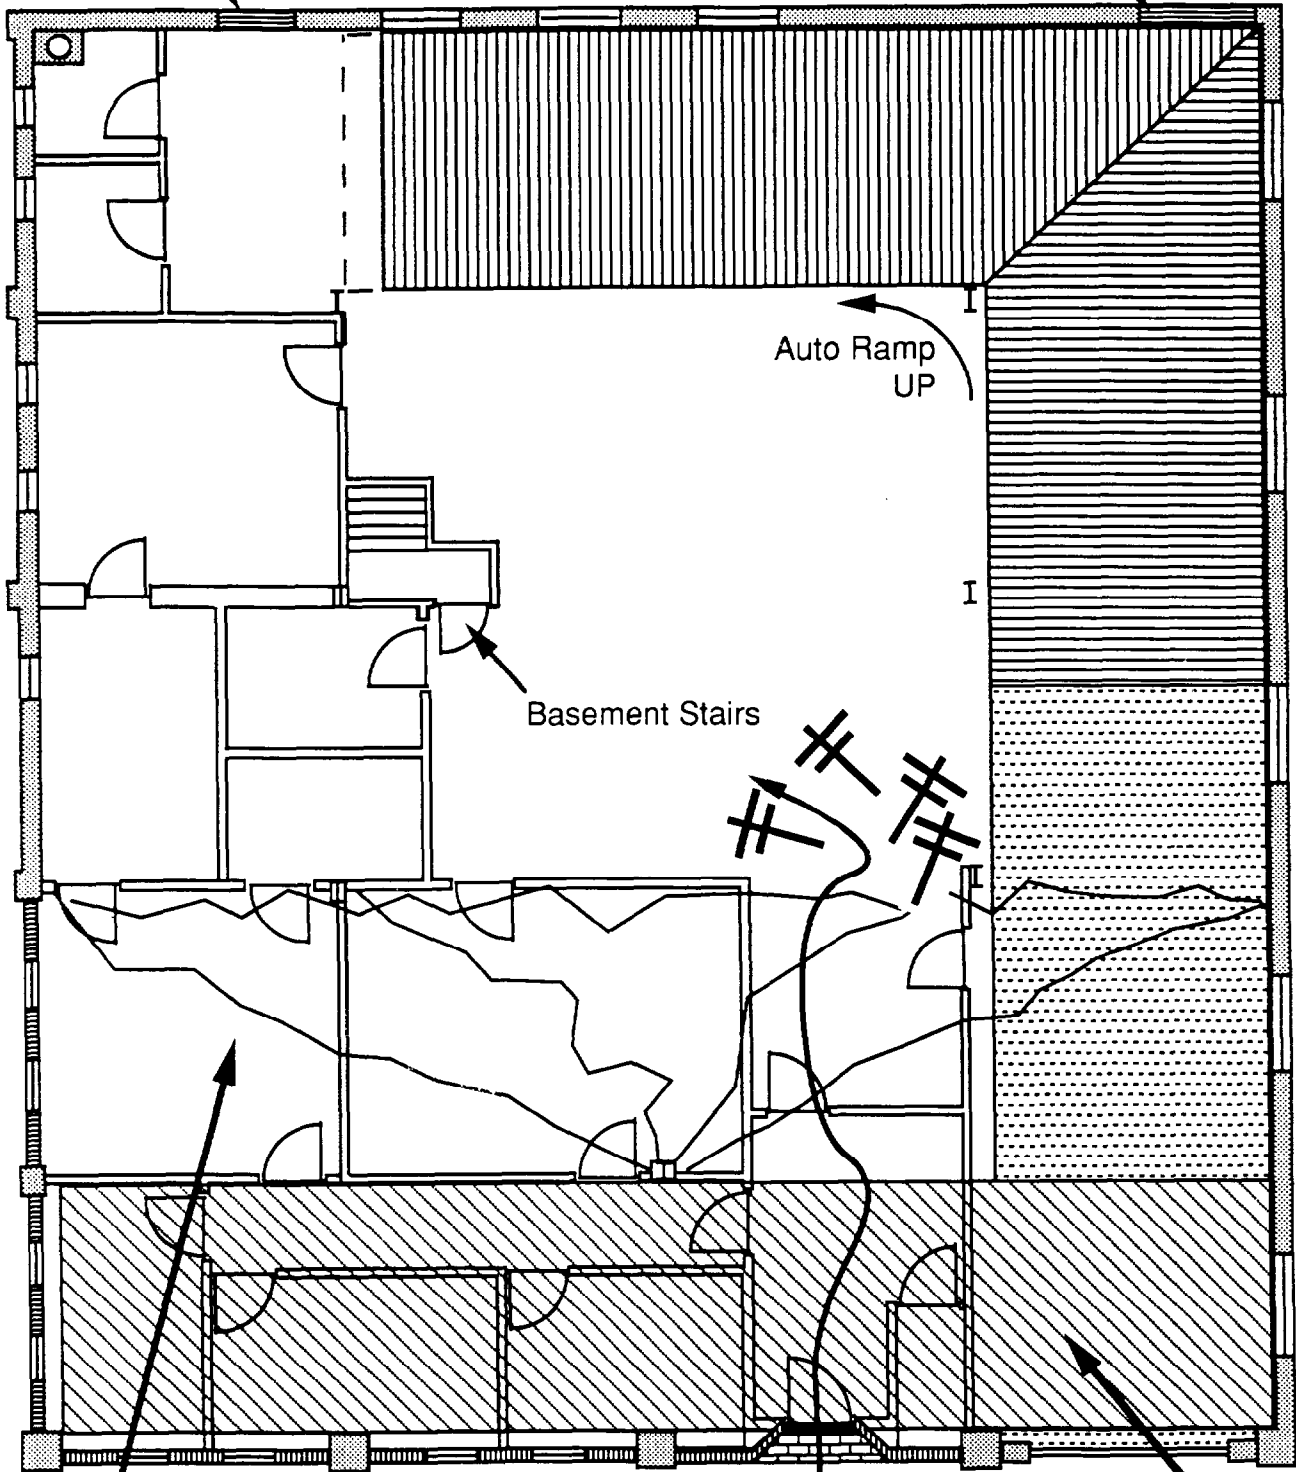
**Initial Fire Attack  
and Location of Victims**

SECONDARY  
COLLAPSE AREA

PRIMARY  
COLLAPSE AREA

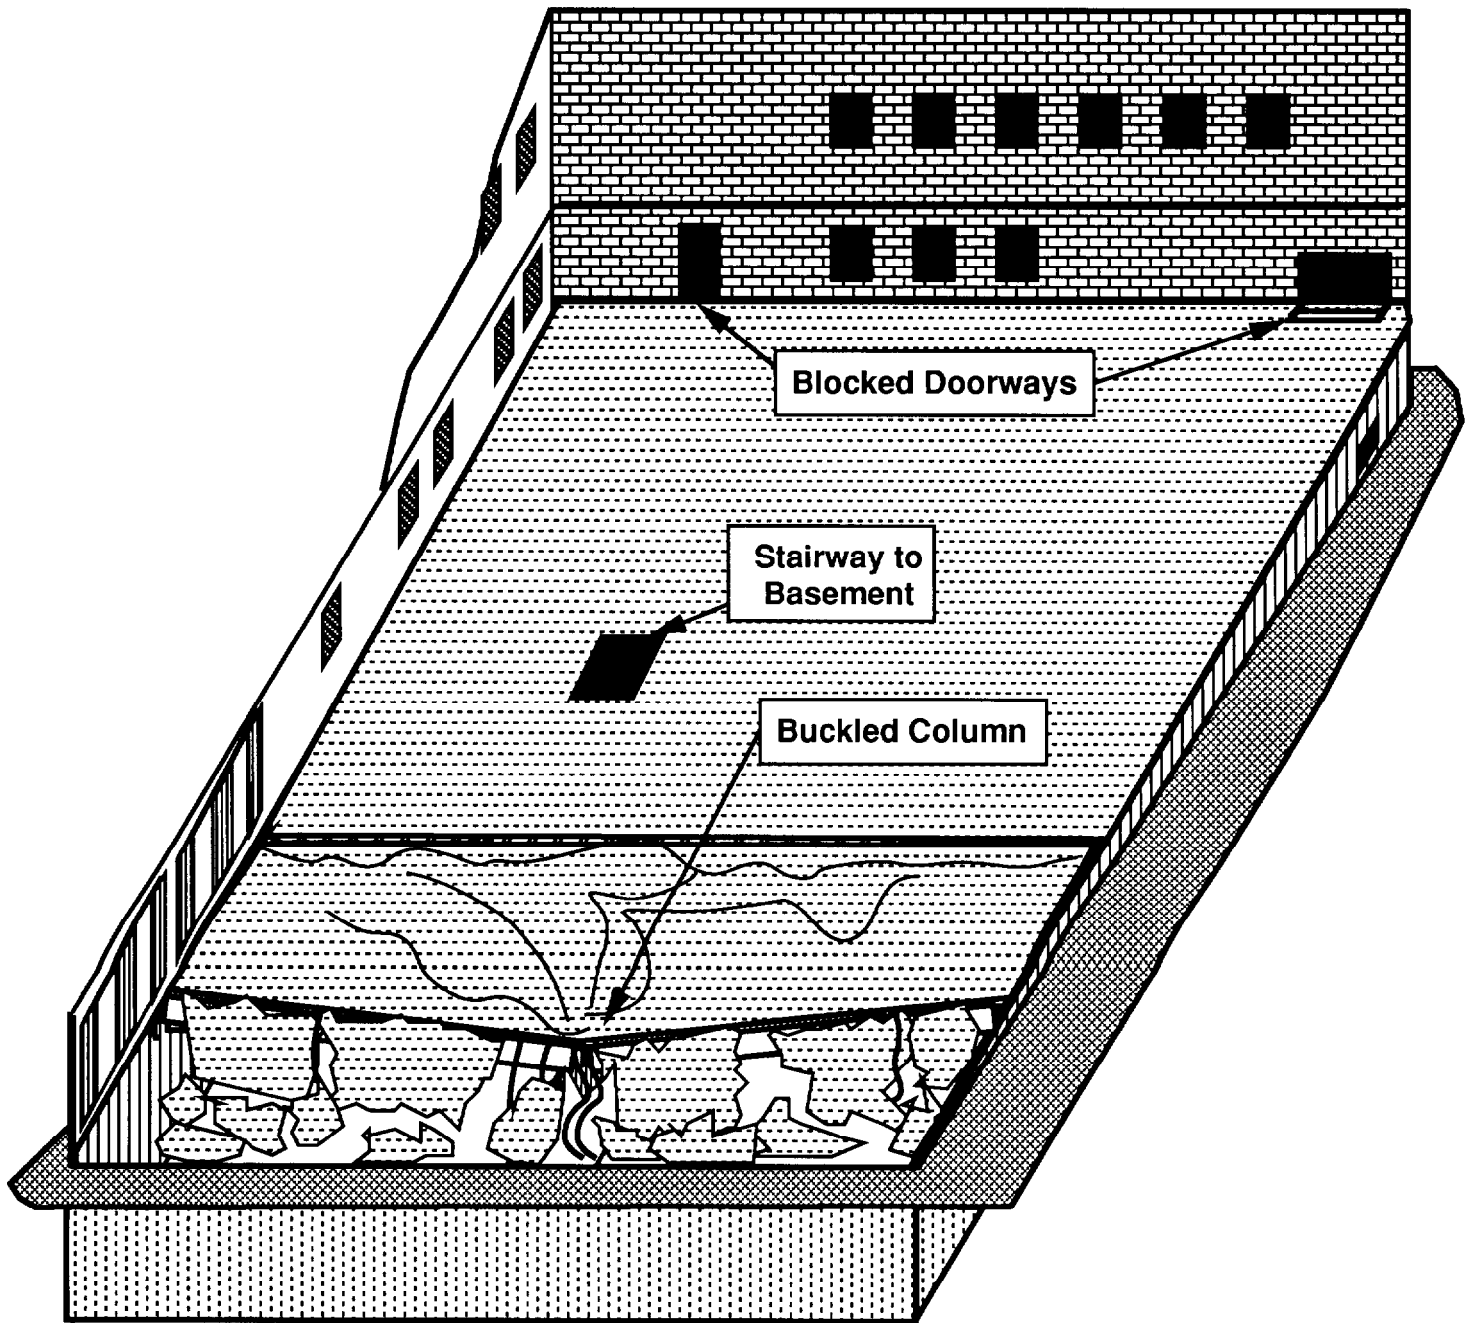
**CUT-AWAY VIEW**  
**Showing Floor Collapse**

The primary structural collapse was caused by the failure of the steel joists supporting the floor slab above the finishing room. All of the joists between the front wall and the first set of support beams failed and dropped the concrete slab into the basement. Examination of the joists found in the rubble indicates that all were severely warped and twisted from heat exposure. The slab broke near the mid-point of the span and some sections were left hanging vertically from the beams. This created an

The middle column supporting the first set of beams was also buckled, although this appears to have been a secondary failure. The buckling of this column caused a secondary slab failure between the first and second sets of beams. The slab in the second bay sloped down toward the opening, with a low point at the center column, but did not drop into the basement. The remainder of the ground floor was not compromised.

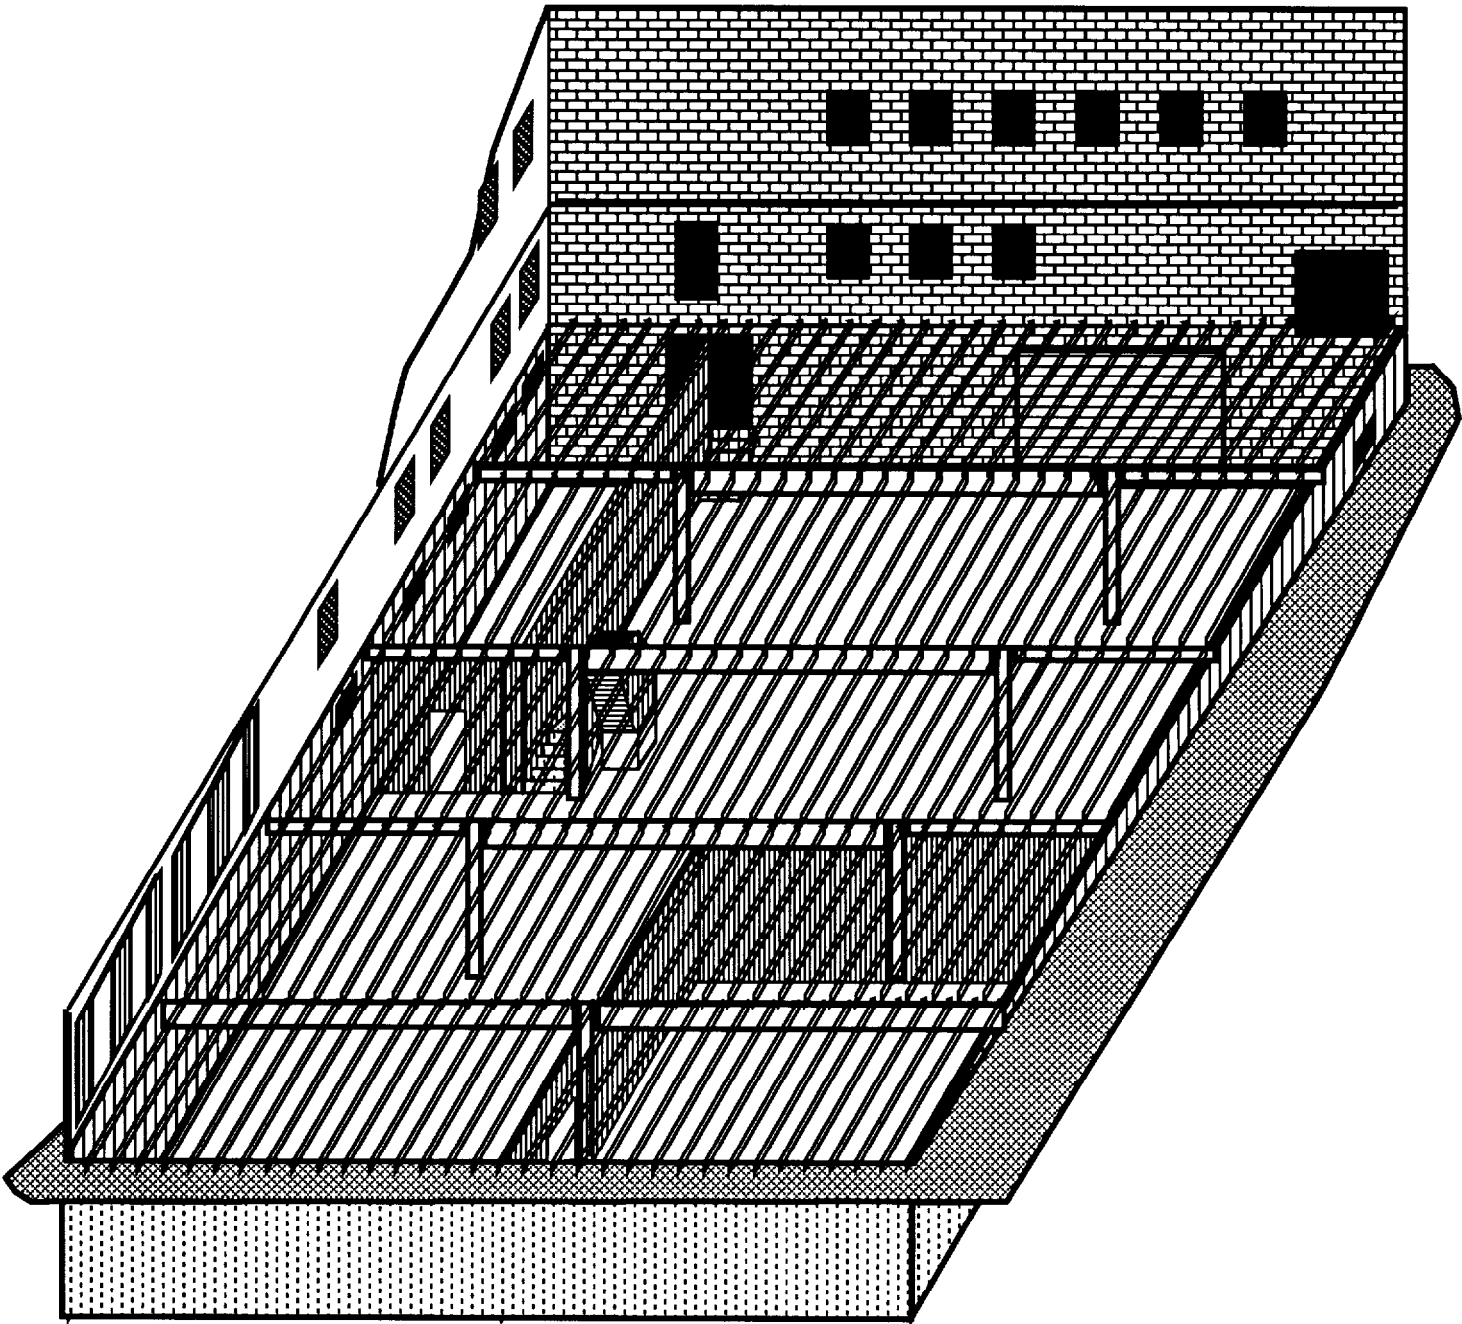
CUT-AWAY VIEW  
Showing Ground Floor Joists

The steel joists above the finishing room were directly exposed to fire for a long period of time. The hot floor condition was noted by the first firefighters entering the building, approximately 35 minutes before the collapse occurred, and it is possible that the fire had been burning in the finishing room for an extended period of time before being discovered.

The individual joists were probably heated to the point of failure well before the collapse occurred; probably before the Fire Department arrived. They did not collapse immediately, because they were supported by the rigidity of the combined joist and slab assembly and the manner of support at the basement wall.

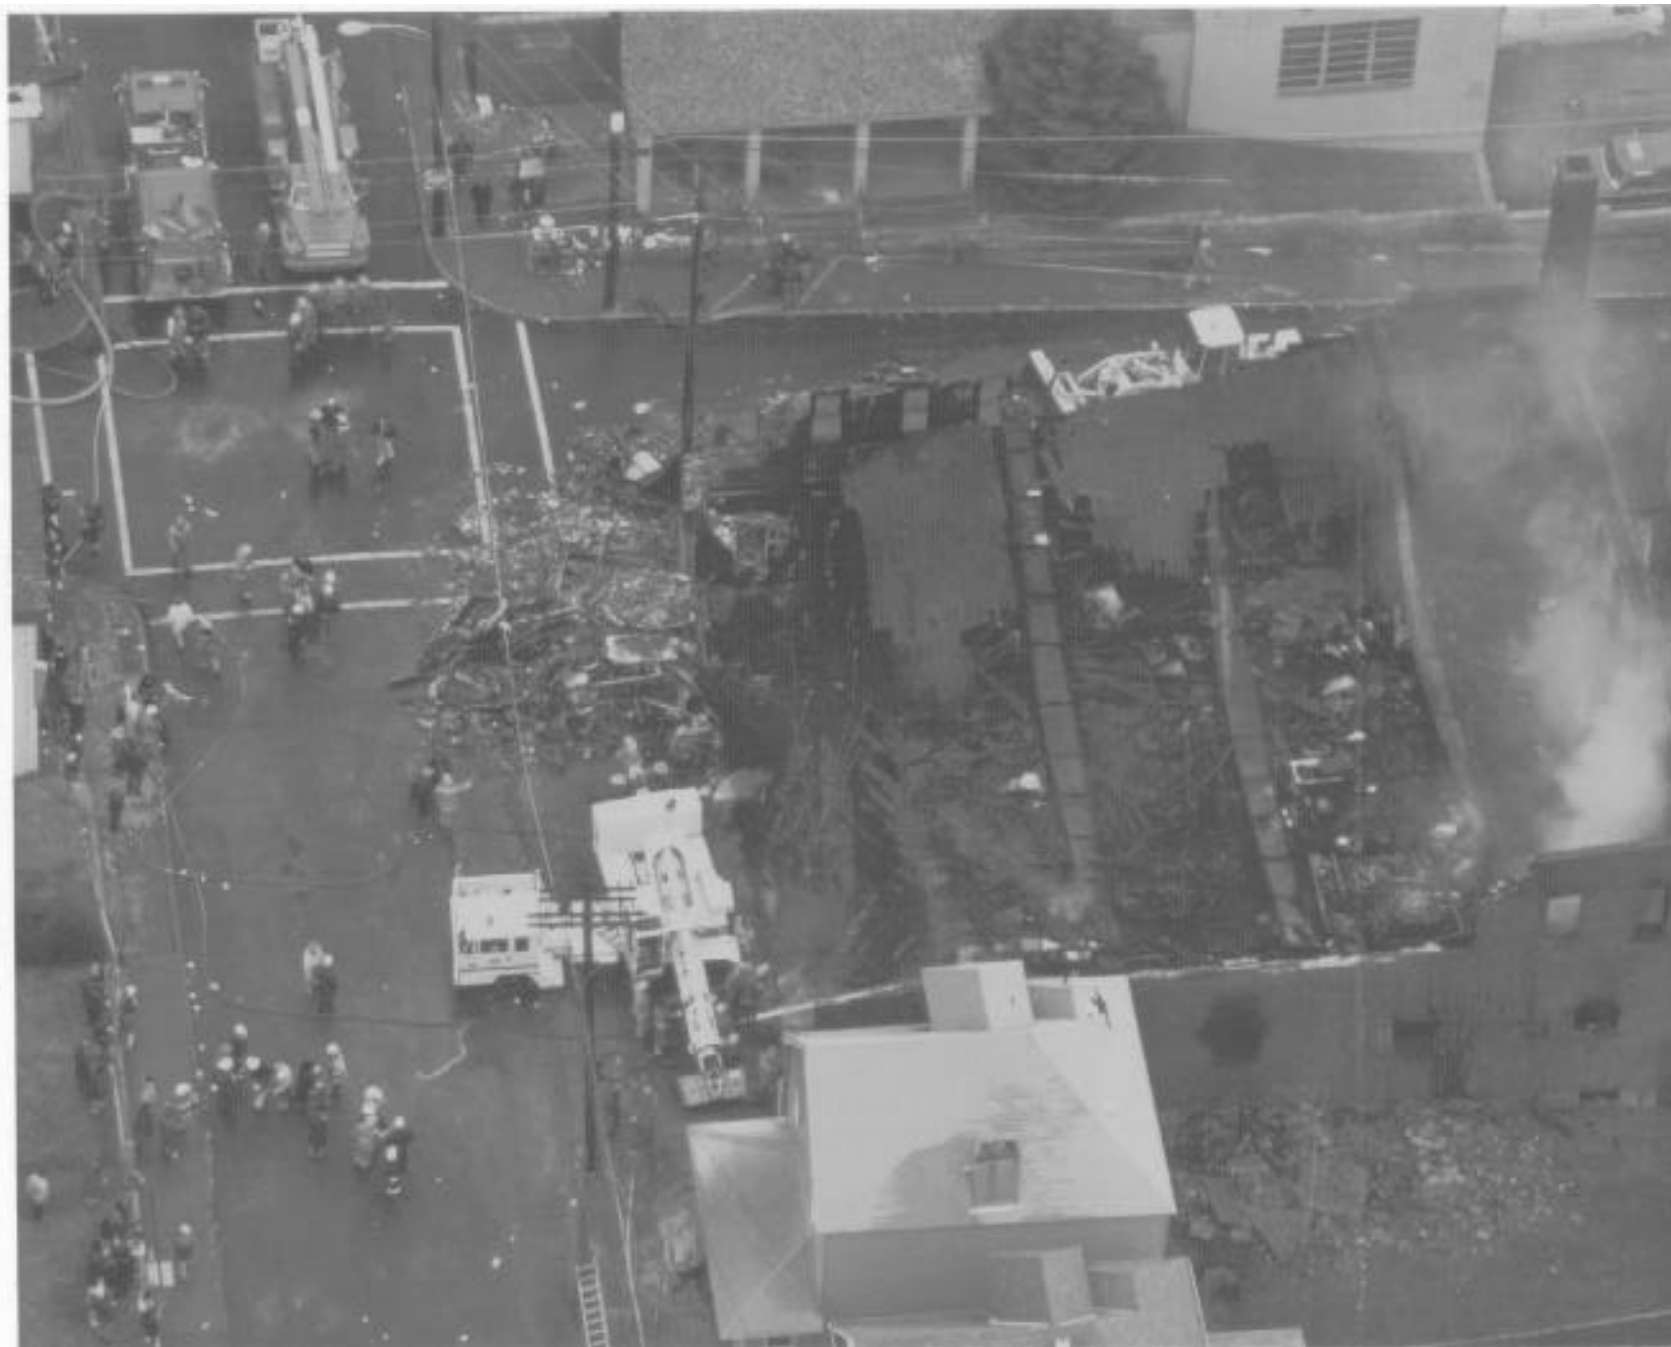
At the height of the fire; firefighters have pulled back.

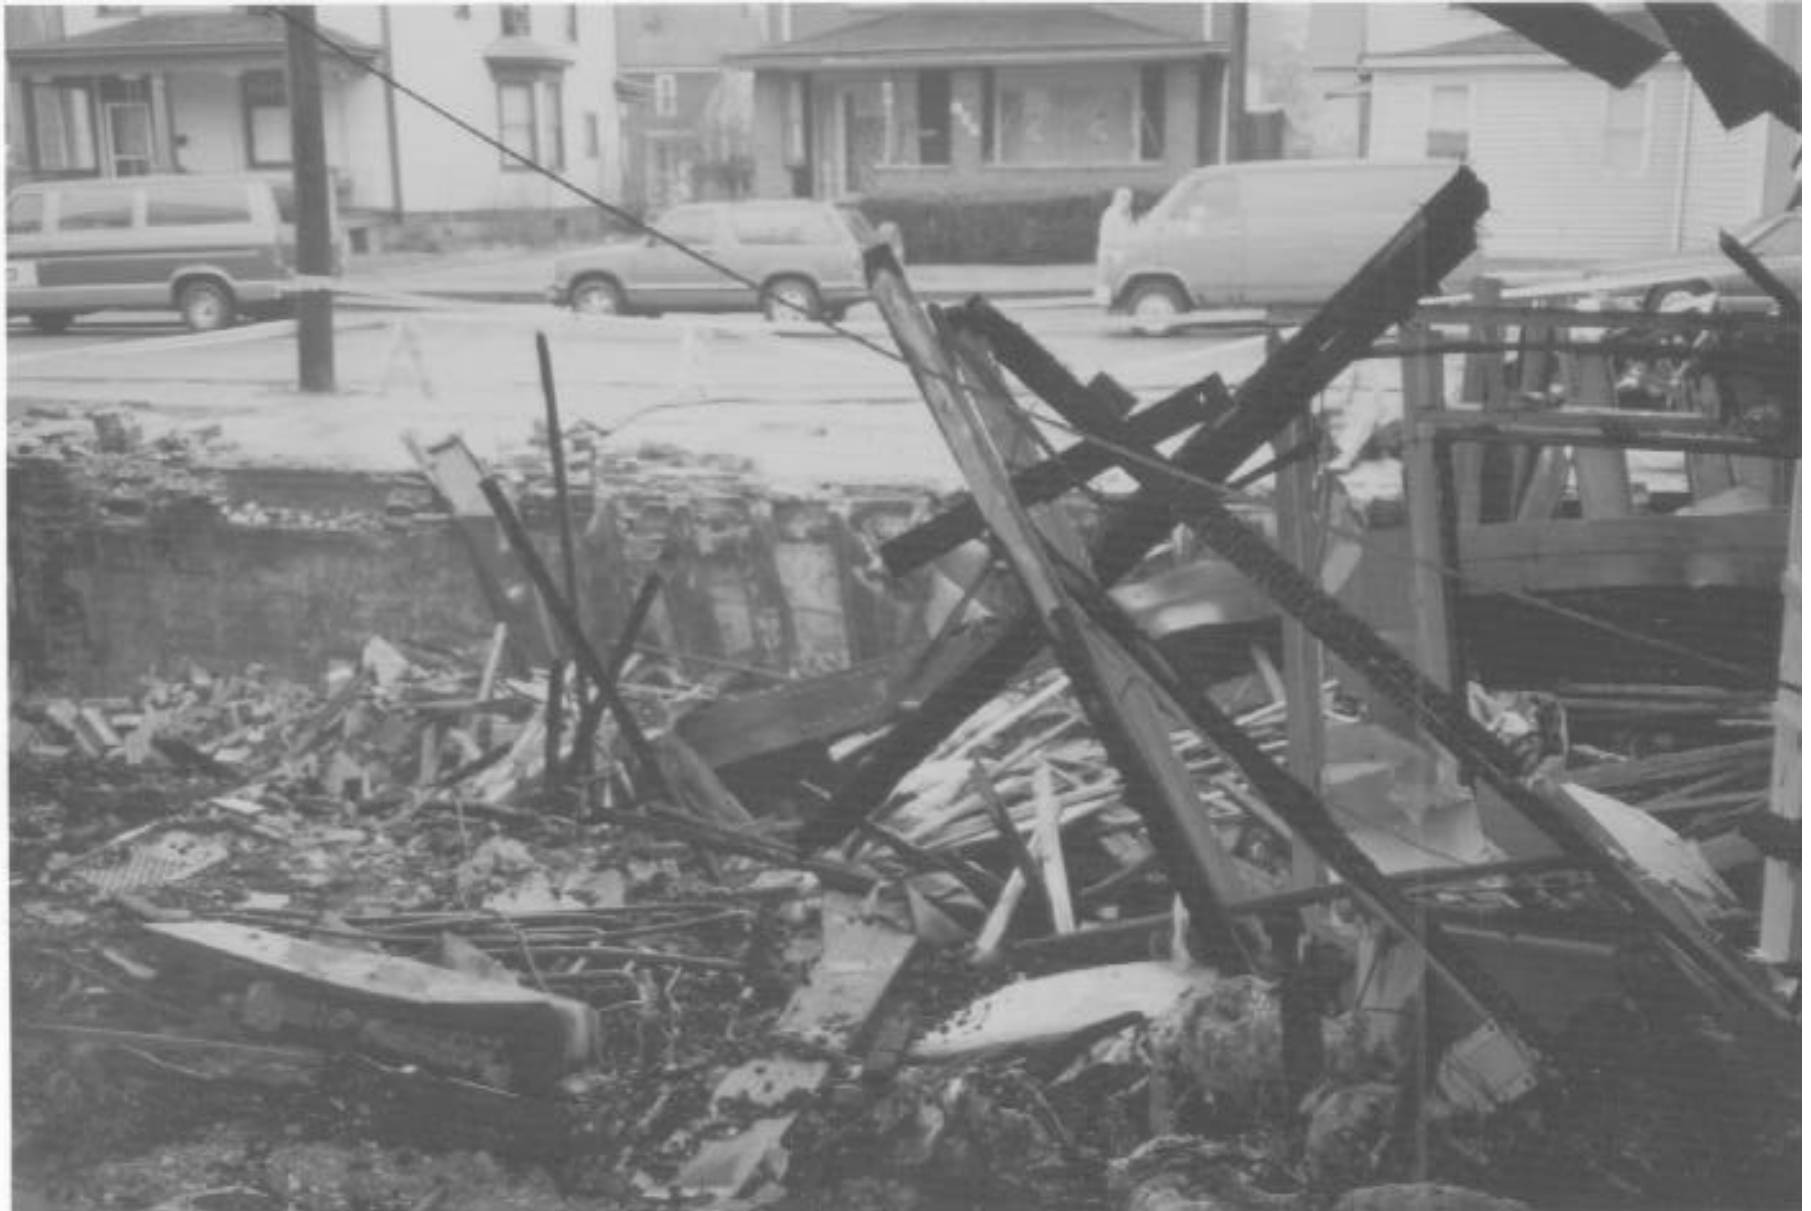
The entire roof and most of the second floor collapsed into the rubble during the fire. The initial structural collapse involved only the one section of the first floor slab. The center column failed later, after severe fire exposure. The remaining beams and columns in the basement were not compromised, although most of the joists were warped and twisted.

Aerial view of fire building after the fire.

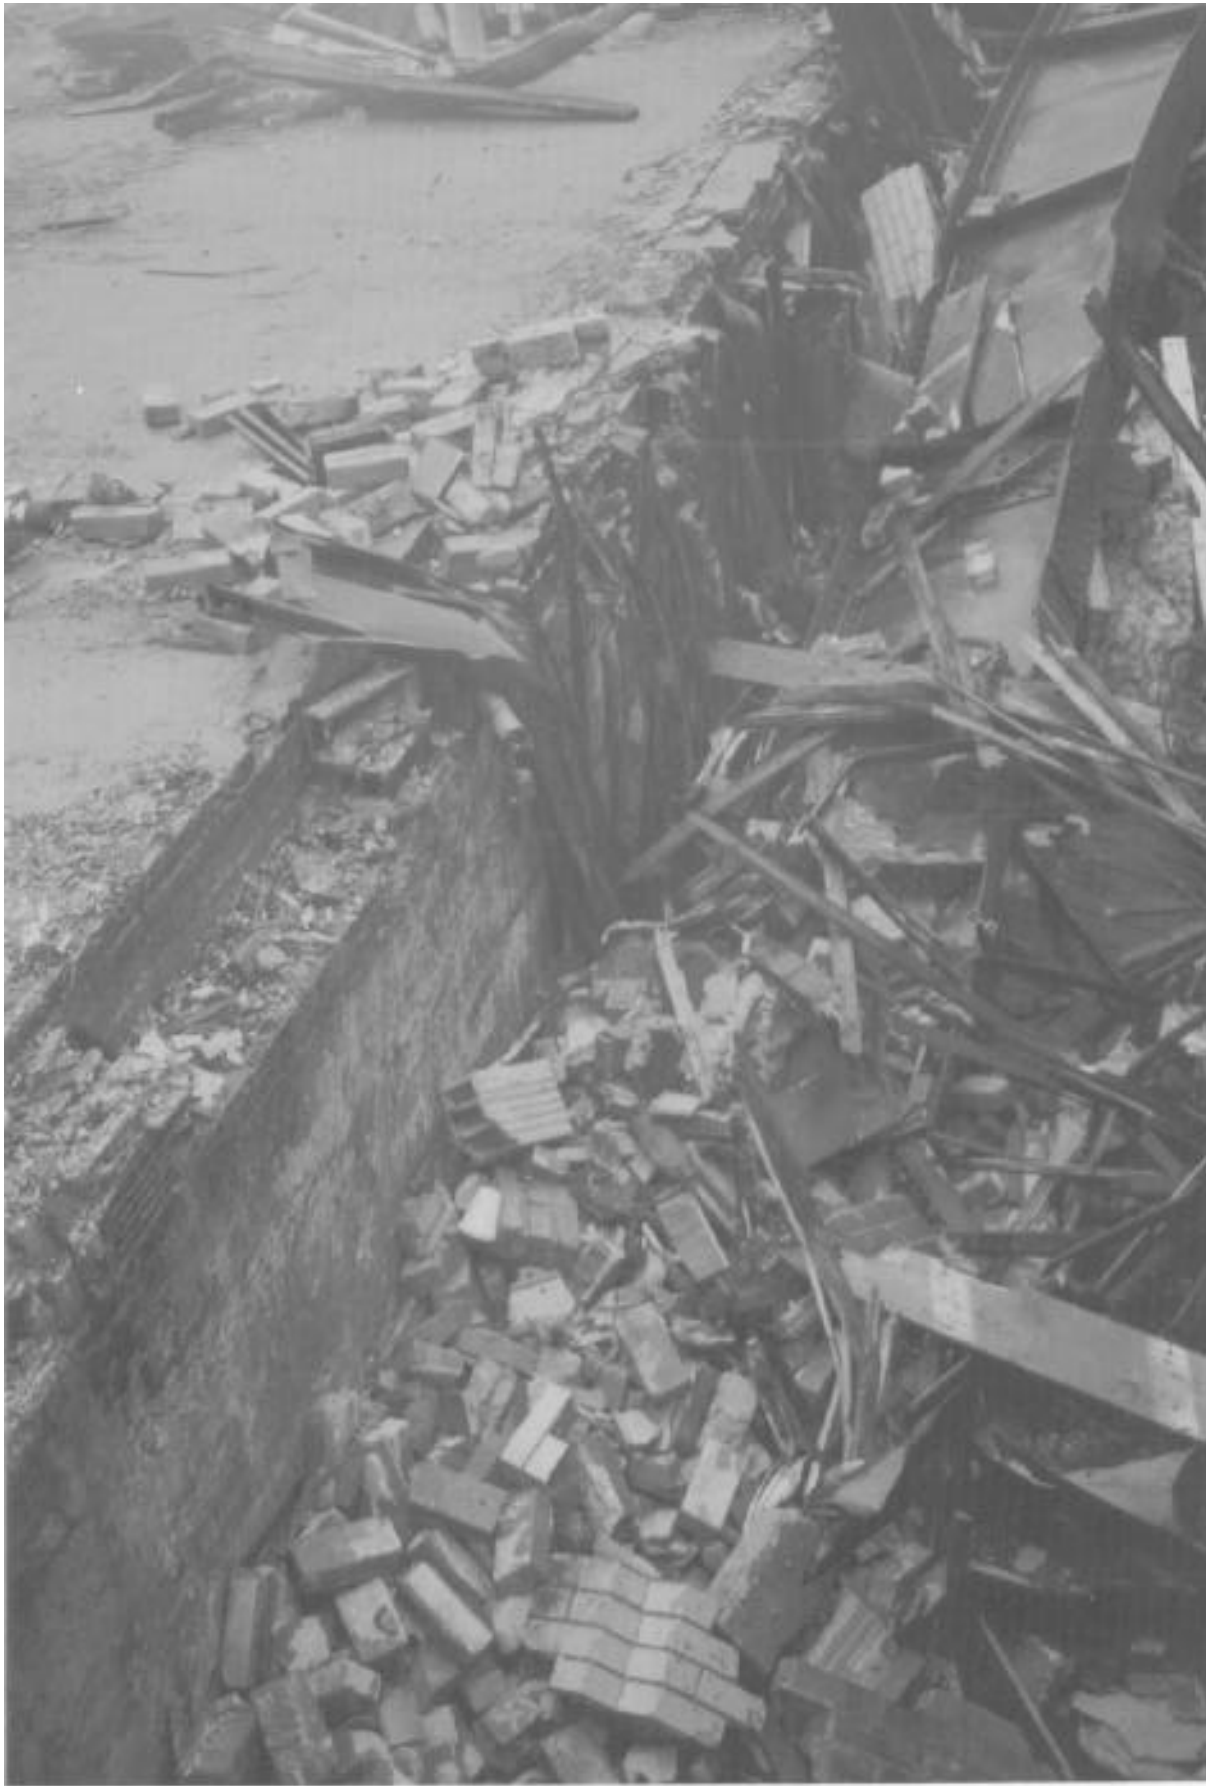
The anchorages of some of the joists at the front of the building were severely corroded, particularly in the area under the door leading to the vehicle ramp. These particular joists were so severely corroded that they may not have been able to support a routine load.

Looking toward Brackenridge Ave. from ground floor, near location where bodies were found. Debris in foreground is from first and second floors and from roof structure. Bent-over ends of floor joists are visible at the point of attachment to the basement wall.

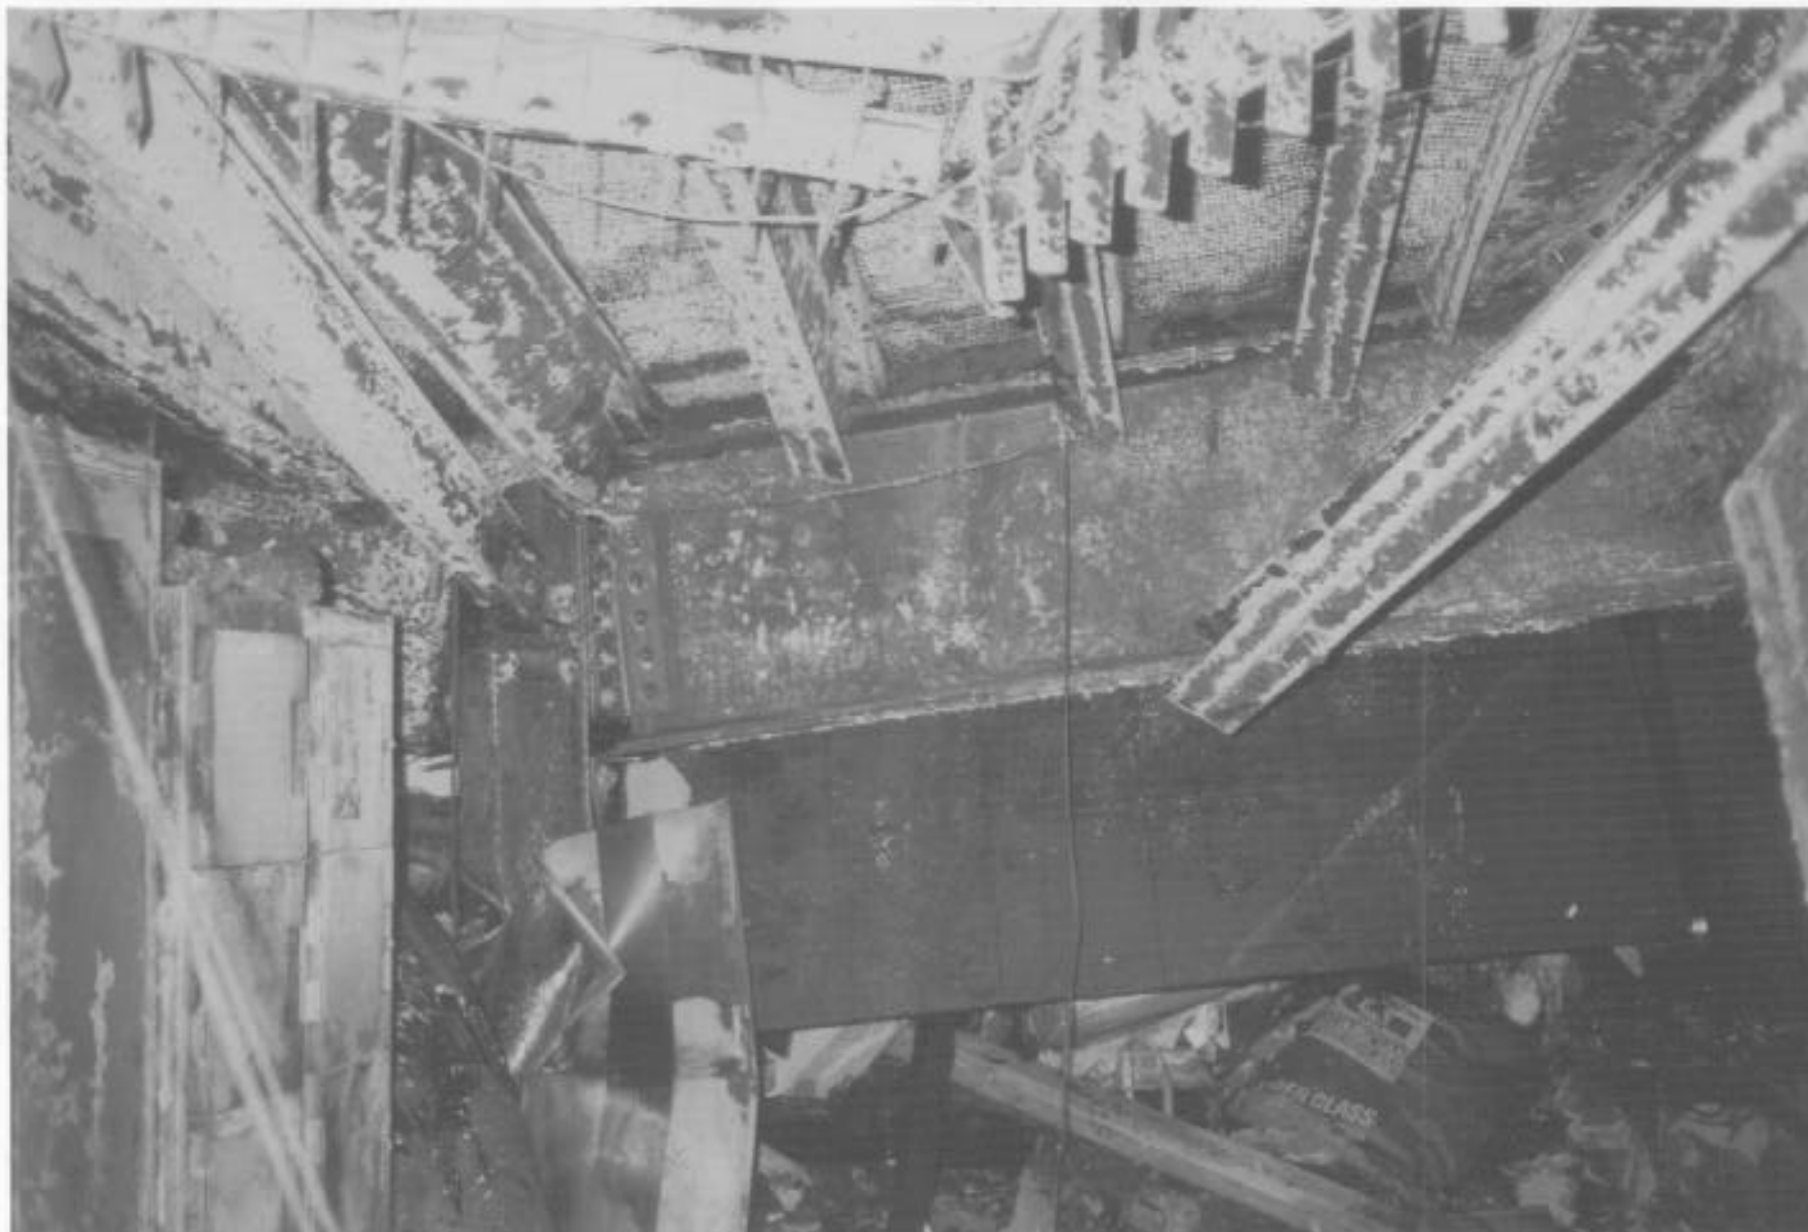
The fire originated in the basement finishing room, which is directly below the front entrance. The investigation indicates that the cause was most likely an accumulation of over-spray residue that was ignited by the electric heating unit. The alternative possibility of spontaneous ignition of chemicals used in the room could not be eliminated. The actual time of ignition is believed to have been as long as several hours before discovery. Investigators believe that the fire may have smoldered for several hours and may have gone through repeated stages of flaming and smoldering combustion, limited by the ventilation that was available to sustain flaming combustion.

Partial view of exhaust duct for spray booth air discharges. Rear of metal spray booths and remnants of enclosure wall are visible.

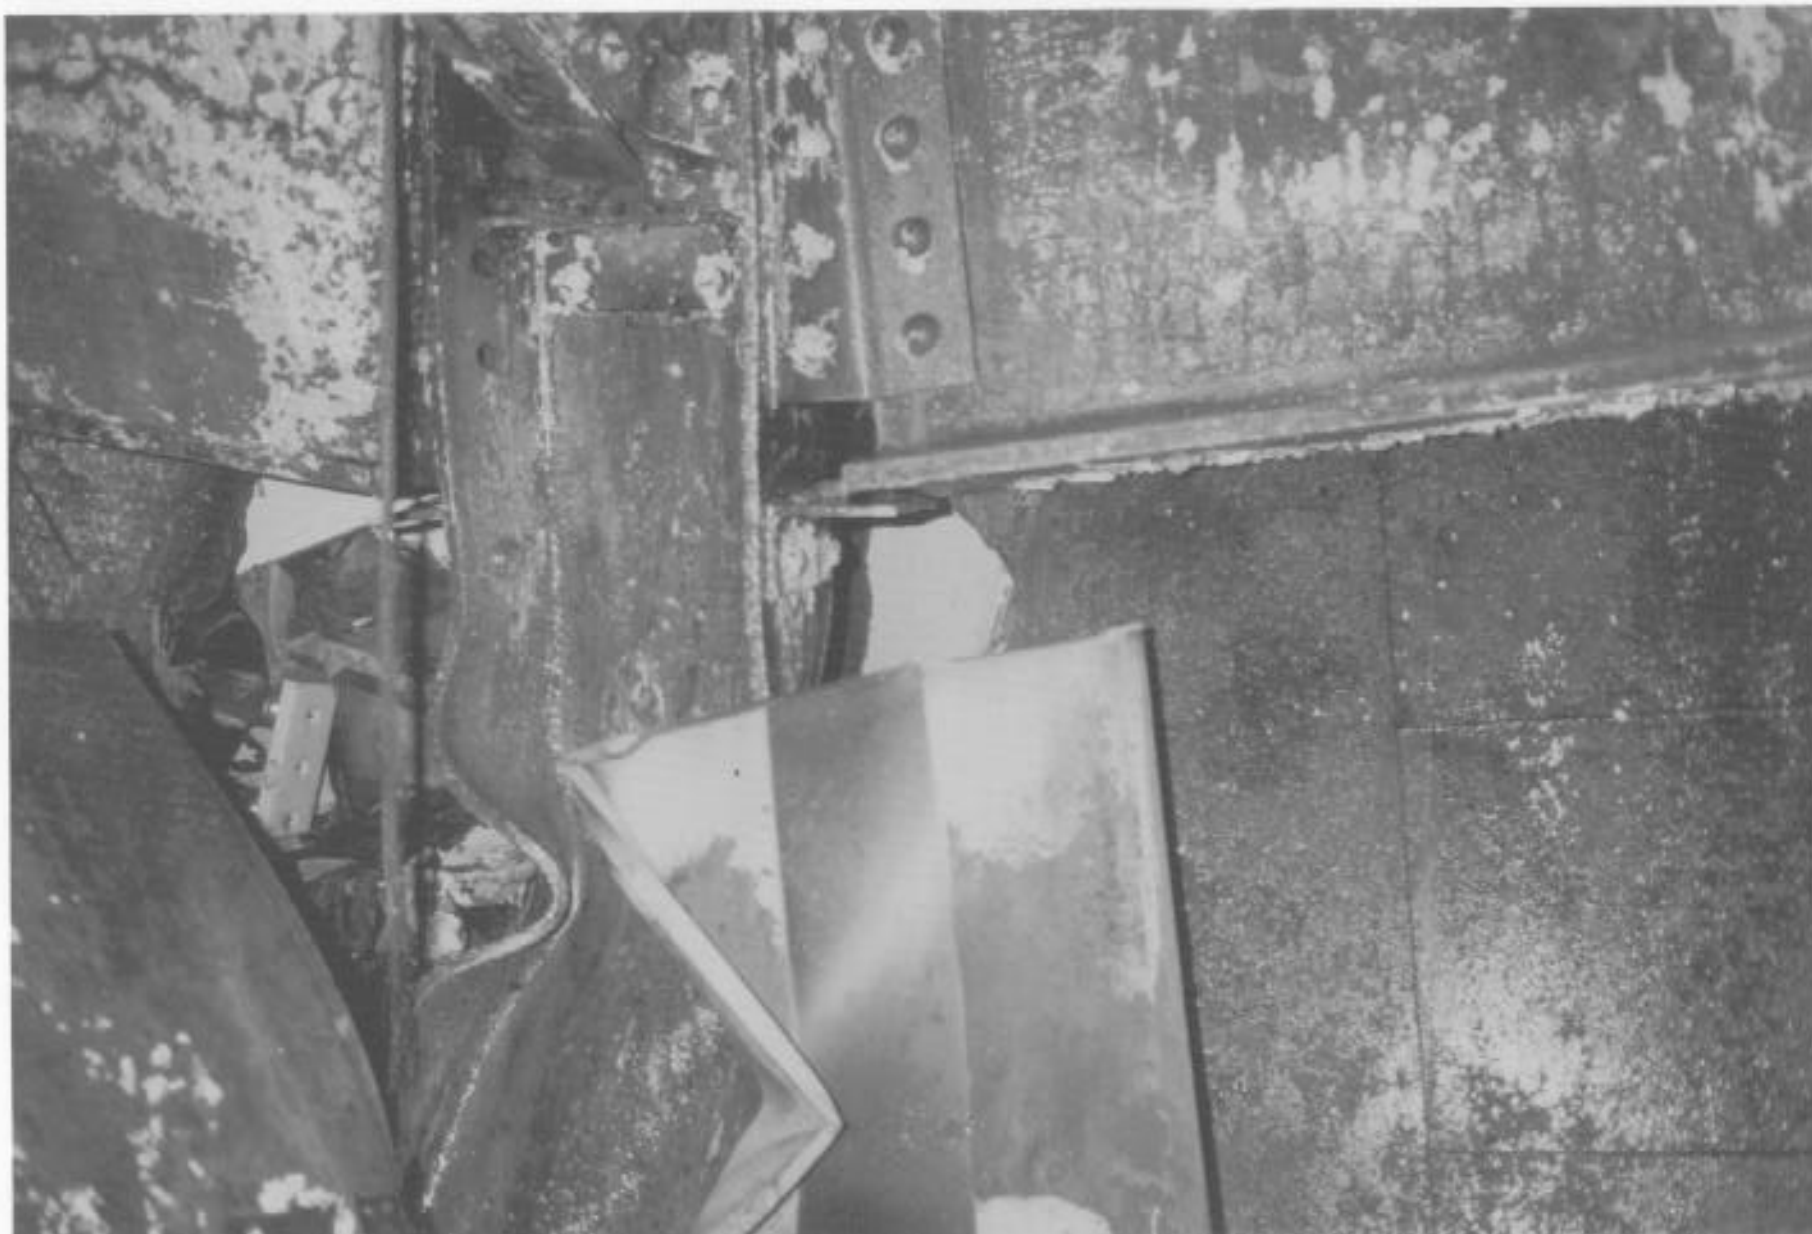
Connection between buckled center column and main beam. Note floor section hanging from opposite side of beam.

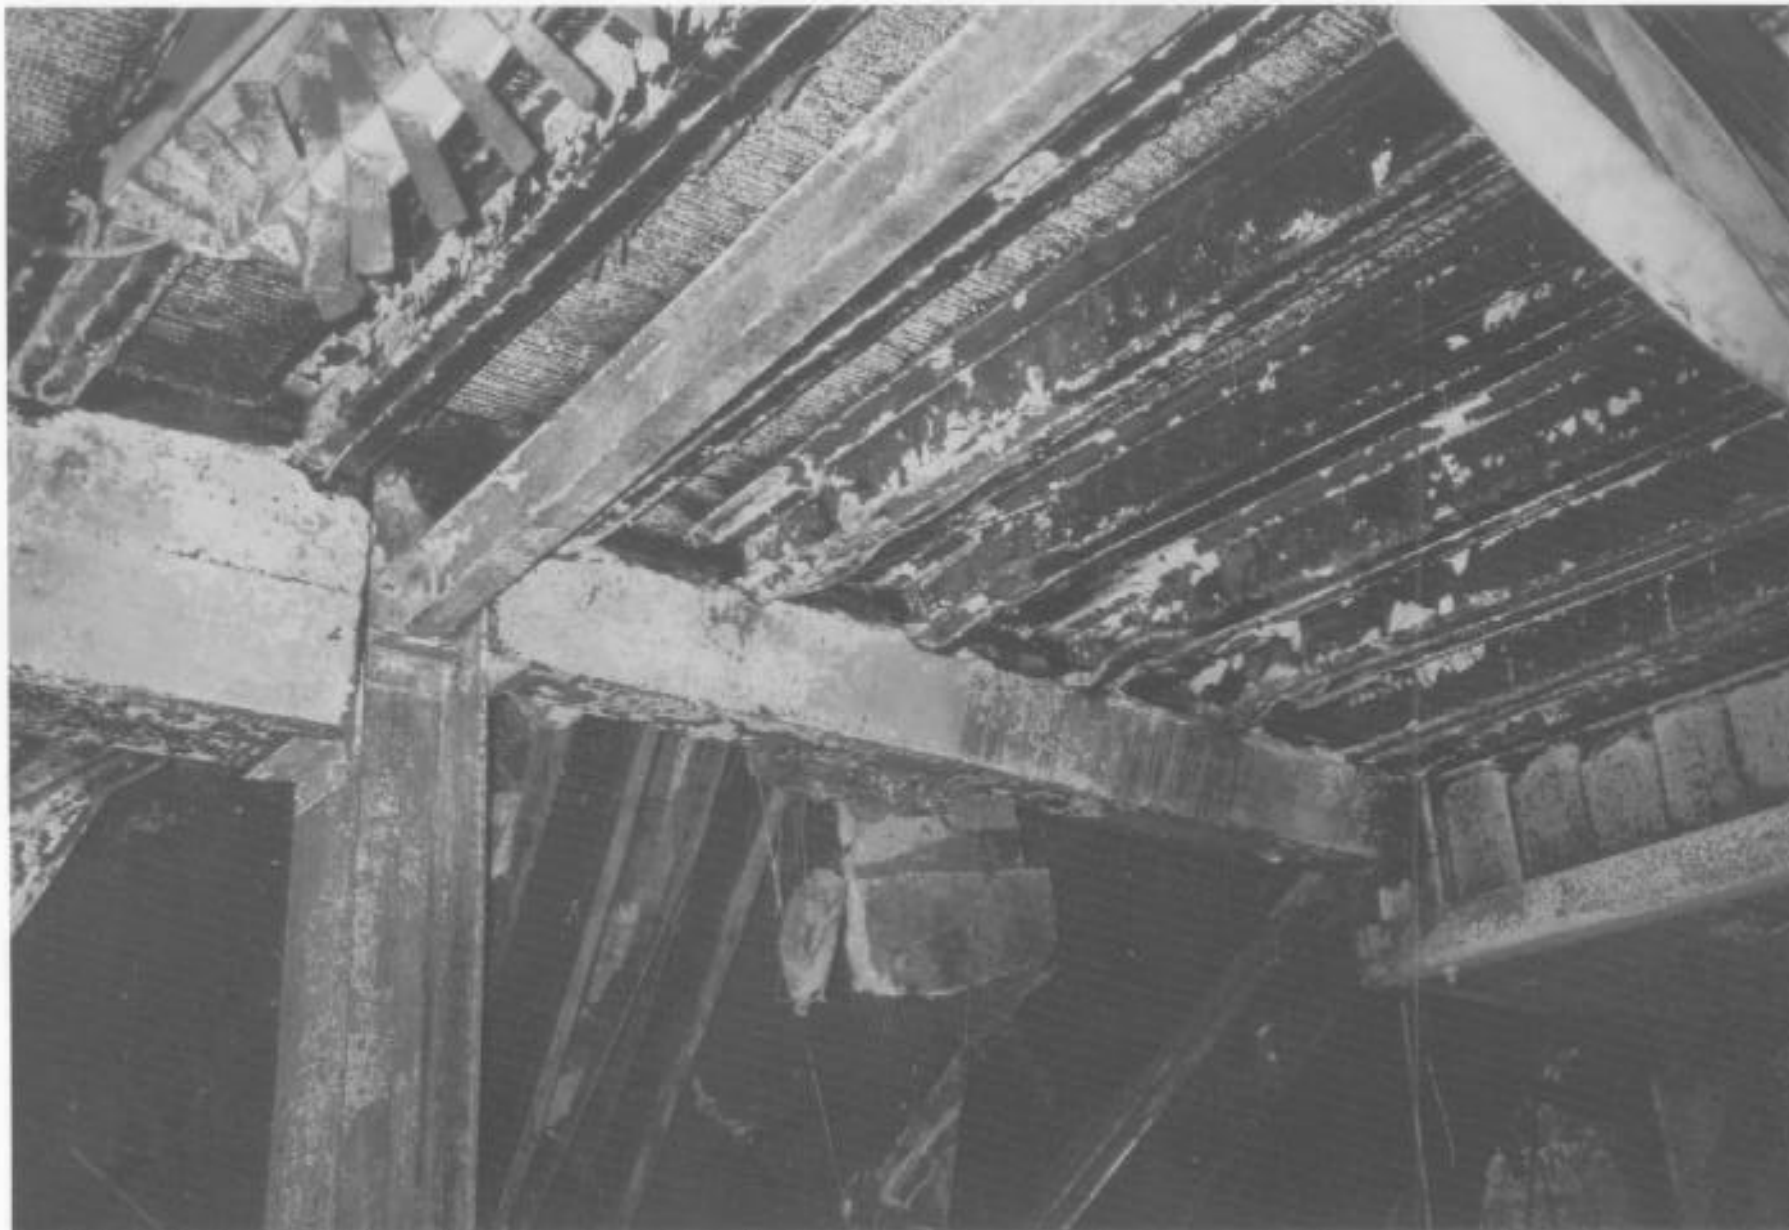
Detail of buckled center column, showing damaged connection of horizontal beam.

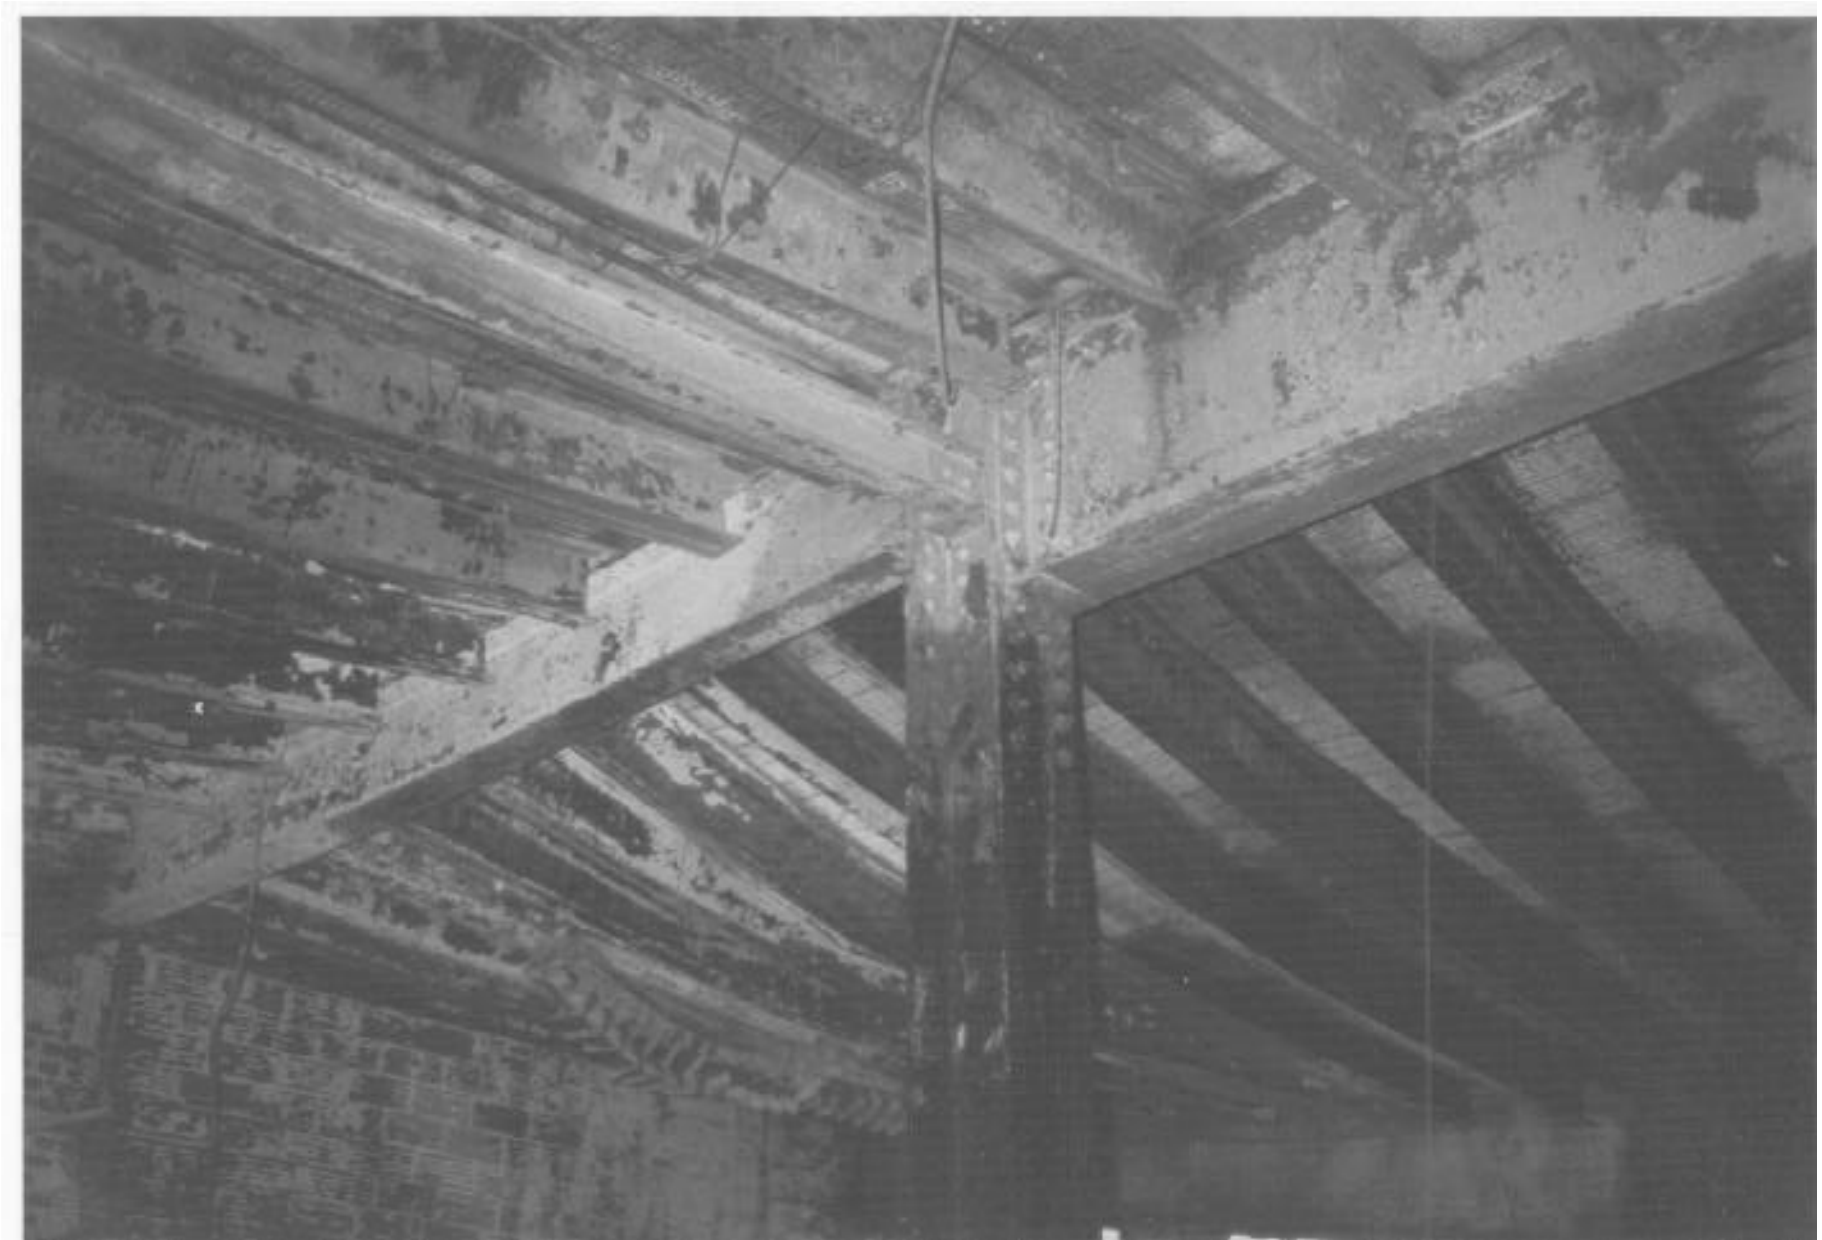
Basement steel beams, encased in concrete, on each side of unprotected column.
